Flood Control Project Maintenance
Levee Inspections

Fall 2012 Levee Maintenance Deficiency Summary Report

Reclamation District No. 0544 Upper Roberts Island

Levee Inspection Report By Mile - Fall 2012

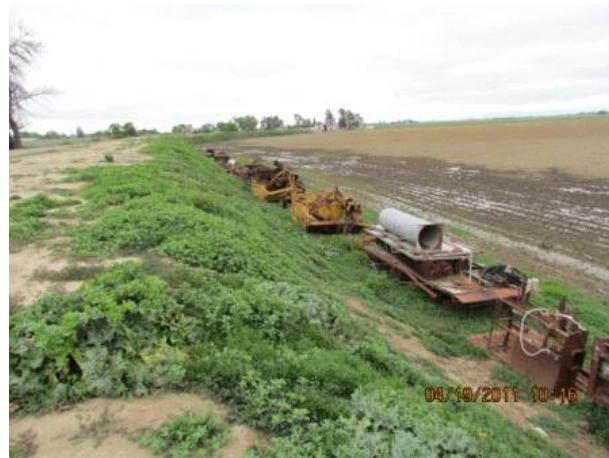
Levee Mile Report Line	4
Start Levee Mile	0.05
End Levee Mile	0.18
Location	Land Side
Category	Earthen Levee
Item	Encroachments
Looking south at equipment along landside toe.	
richard_f_20121012_427.jpg

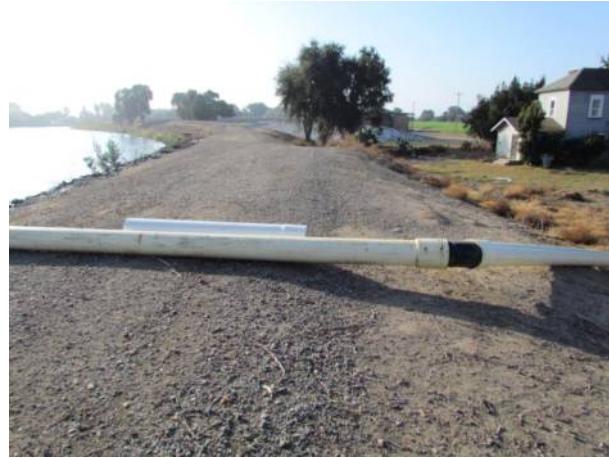
Levee Mile Report Line	20
Start Levee Mile	1.80
End Levee Mile	1.80
Location	Crown
Category	Earthen Levee
Item	Encroachments
Looking south at drain pipe across levee crown.	
richard_f_20121101_901.JPG

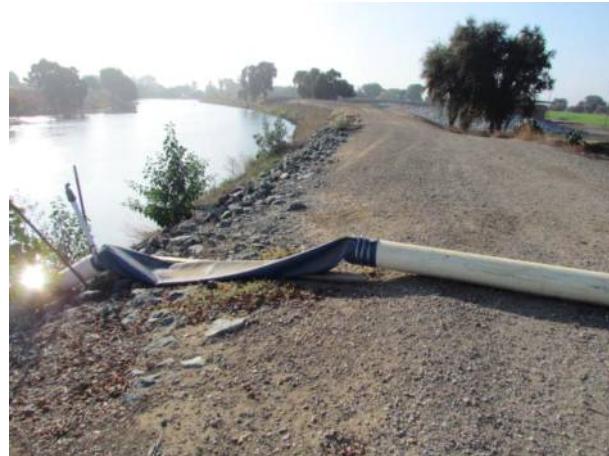
Levee Mile Report Line	20
Start Levee Mile	1.80
End Levee Mile	1.80
Location	Crown
Category	Earthen Levee
Item	Encroachments
Looking southeast at drain pipe blocking access to levee.	
richard_f_20121101_902.JPG

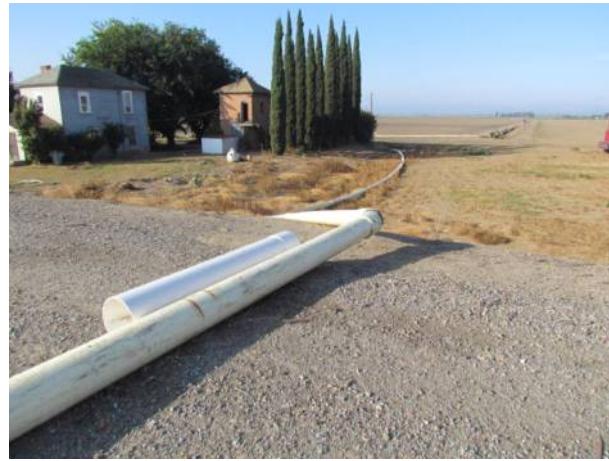
Levee Mile Report Line	20
Start Levee Mile	1.80
End Levee Mile	1.80
Location	Crown
Category	Earthen Levee
Item	Encroachments
Looking west at drain pipe crossing levee from landside.	
richard_f_20121101_903.JPG

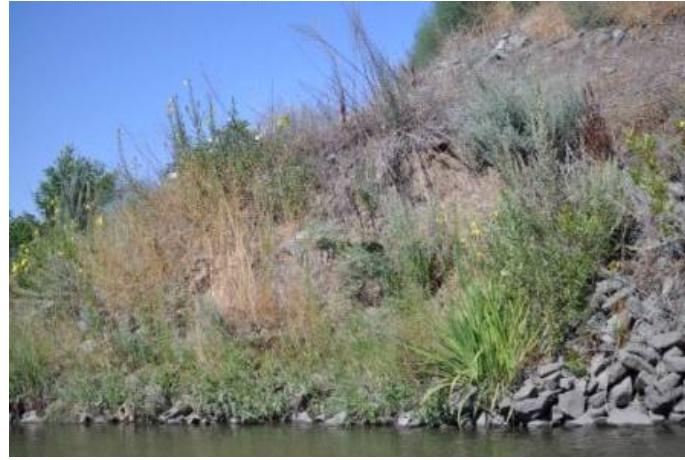
Levee Mile Report Line	24
Start Levee Mile	2.01
End Levee Mile	2.01
Location	Water Side
Category	Supplemental
Item	DWR Erosion Survey
Front view of erosion	
SJR2012_RD0544U01RM48.81_1.jpg

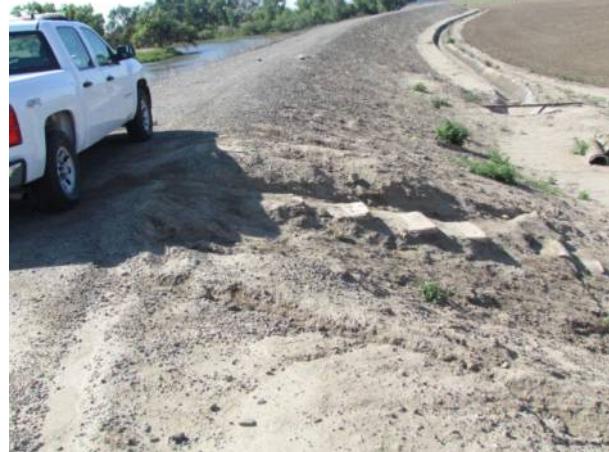
Levee Mile Report Line	30
Start Levee Mile	2.58
End Levee Mile	2.58
Location	Land Side
Category	Earthen Levee
Item	Slope Stability
Looking south at slope damage on landside slope.	
richard_f_20121012_454.jpg

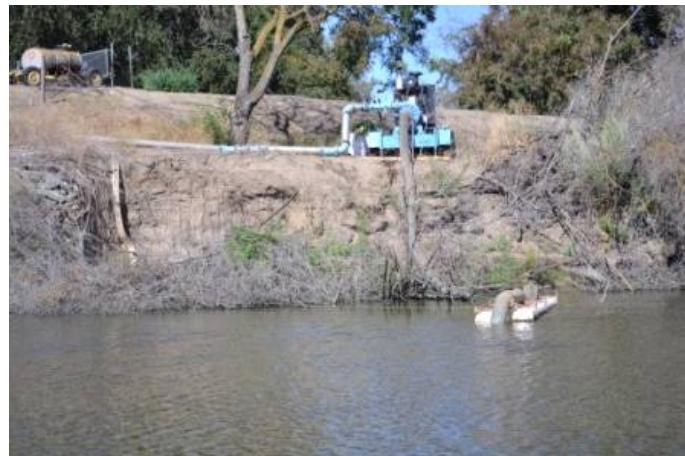
Levee Mile Report Line	32
Start Levee Mile	2.94
End Levee Mile	2.94
Location	Water Side
Category	Supplemental
Item	DWR Erosion Survey
Front view of the erosion. The pumping machine unlikely the cause of the erosion.	
SJR2012_RD0544U01RM49.67_1.jpg

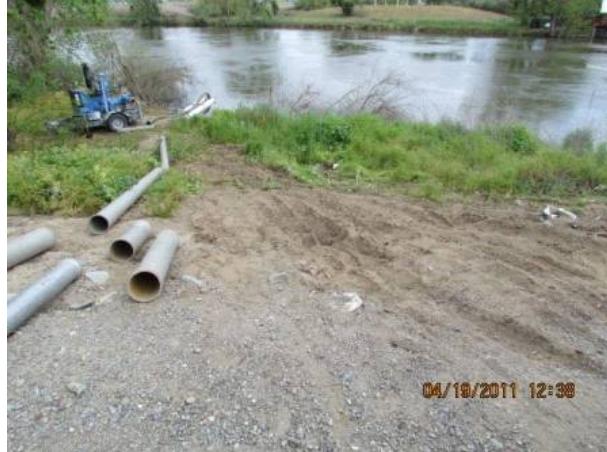
Levee Mile Report Line	34
Start Levee Mile	2.98
End Levee Mile	2.98
Location	Land Side
Category	Earthen Levee
Item	Encroachments
Looking east at landowner installing temporary pump system without permit and damage to waterside slope.	richard_f_20121012_433.jpg

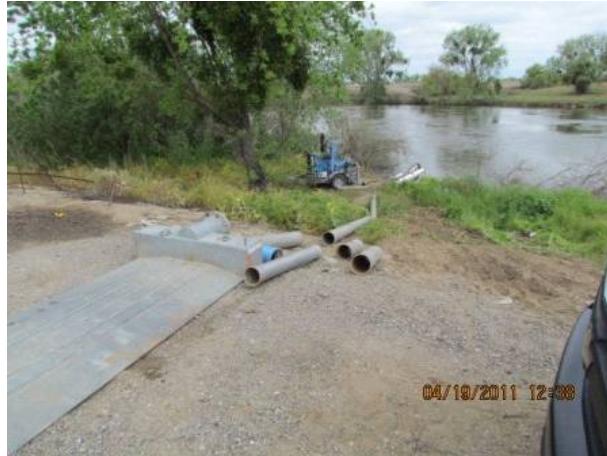
Levee Mile Report Line	34
Start Levee Mile	2.98
End Levee Mile	2.98
Location	Land Side
Category	Earthen Levee
Item	Encroachments
Looking east at pump and irrigation ramp on levee waterside and crown.	richard_f_20121012_434.jpg

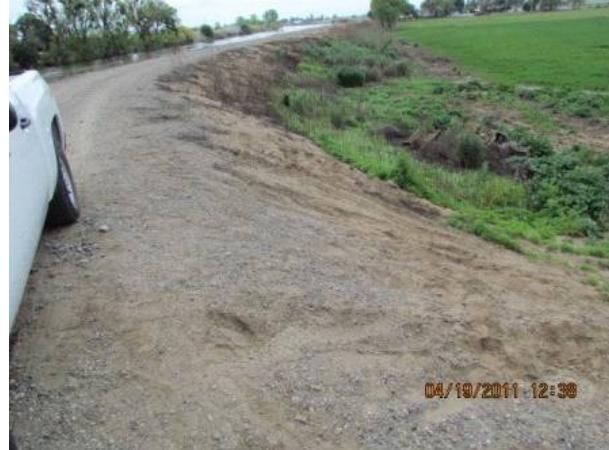
Levee Mile Report Line	34
Start Levee Mile	2.98
End Levee Mile	2.98
Location	Land Side
Category	Earthen Levee
Item	Encroachments
Looking south at damage landside slope caused by vehicle traffic.	
richard_f_20121012_435.jpg

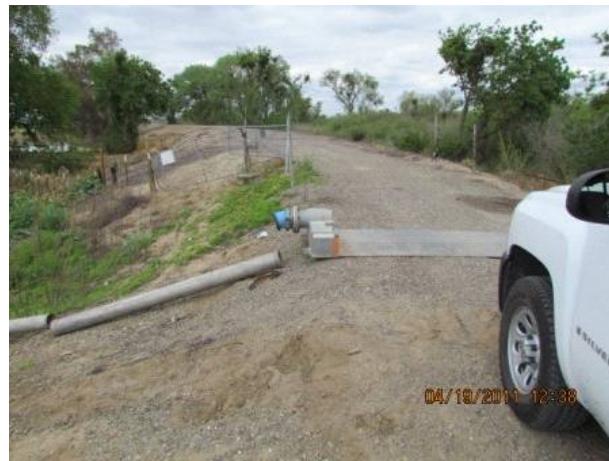
Levee Mile Report Line	34
Start Levee Mile	2.98
End Levee Mile	2.98
Location	Land Side
Category	Earthen Levee
Item	Encroachments
Looking north at pipe and pipe ramp on landside and crown of levee.	
richard_f_20121012_436.jpg

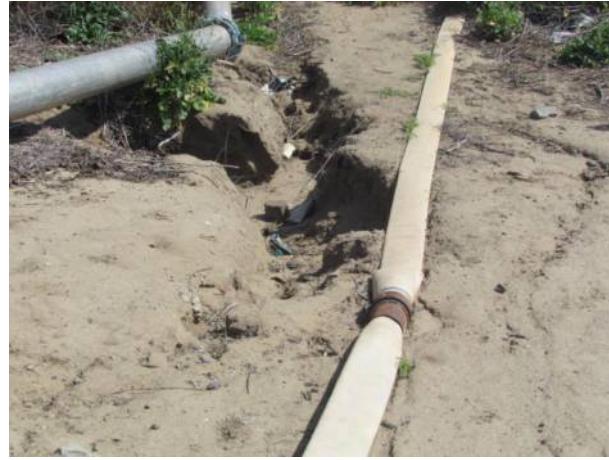
Levee Mile Report Line	34
Start Levee Mile	2.98
End Levee Mile	2.98
Location	Land Side
Category	Earthen Levee
Item	Encroachments
Looking east at erosion caused by leaking pipe on waterside slope.	
richard_f_20121012_437.jpg

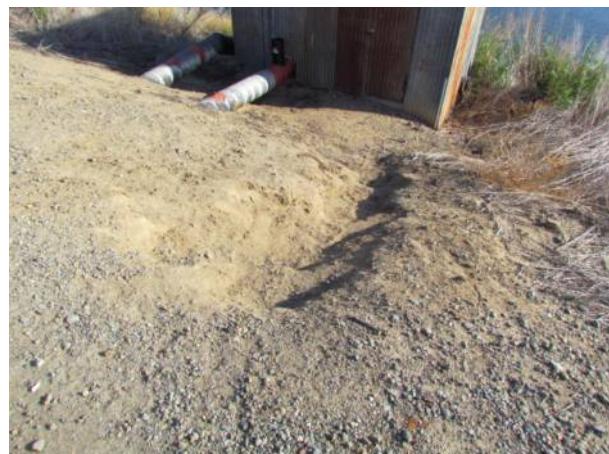
Levee Mile Report Line	35
Start Levee Mile	3.19
End Levee Mile	3.19
Location	Water Side
Category	Earthen Levee
Item	Slope Stability
Looking east at slope damage by foot traffic near pump house on waterside of levee.	
richard_f_20121101_904.JPG

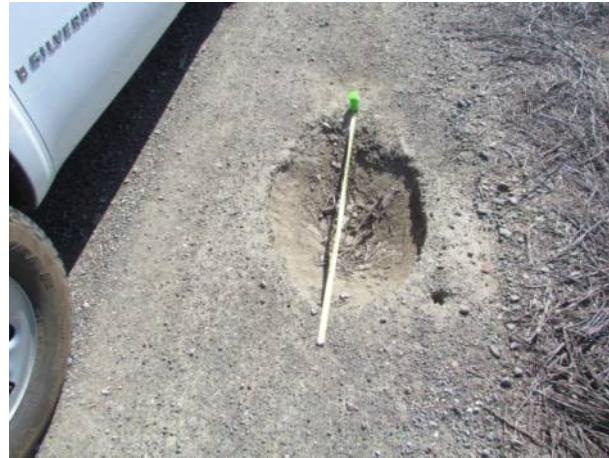
Levee Mile Report Line	46
Start Levee Mile	4.20
End Levee Mile	4.20
Location	Crown
Category	Earthen Levee
Item	Erosion / Bank Caving
Looking north at sink hole on levee crown.	
richard_f_20121012_430.jpg

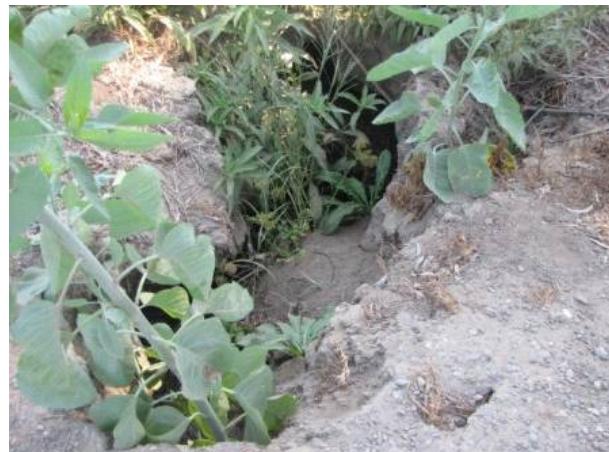
Levee Mile Report Line	48
Start Levee Mile	4.32
End Levee Mile	4.32
Location	Water Side
Category	Earthen Levee
Item	Slope Stability
Looking east at erosion on waterside slope and berm cause by leaking 10" pipe.	
richard_f_20121012_449.jpg

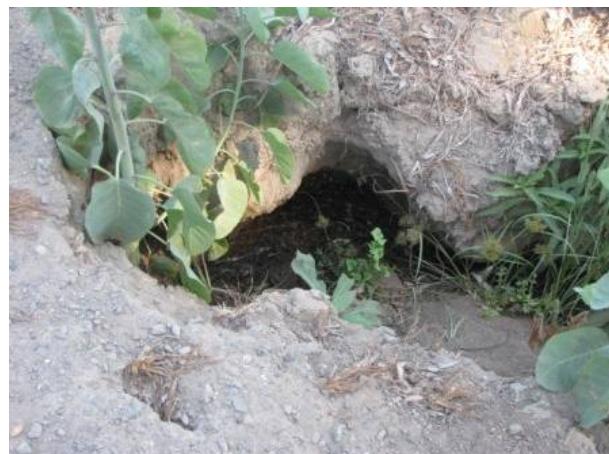
Levee Mile Report Line	48
Start Levee Mile	4.32
End Levee Mile	4.32
Location	Water Side
Category	Earthen Levee
Item	Slope Stability
Looking west at hole on waterside shoulder and slope cause by possible broken pipe.	
richard_f_20121012_450.jpg

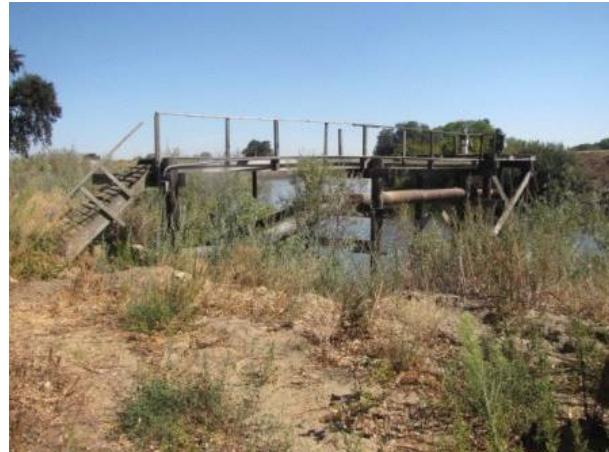
Levee Mile Report Line	48
Start Levee Mile	4.32
End Levee Mile	4.32
Location	Water Side
Category	Earthen Levee
Item	Slope Stability
Looking northwest at pump and platform for 10" possible leaking pipe.	
richard_f_20121012_451.jpg

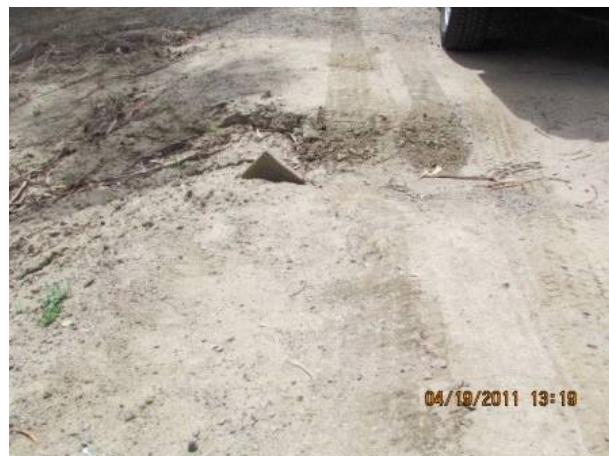
Levee Mile Report Line	50
Start Levee Mile	4.33
End Levee Mile	4.33
Location	Crown
Category	Earthen Levee
Item	Crown Surface / Depressions / Rutting
Looking south at depression greater than 6" on waterside shoulder.	
richard_f_20121012_452.jpg

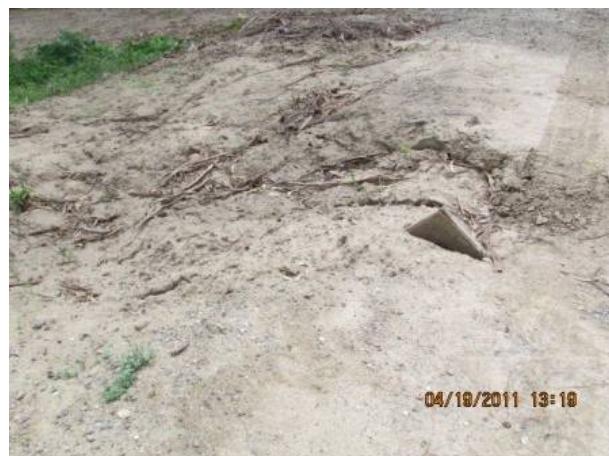
Levee Mile Report Line	50
Start Levee Mile	4.33
End Levee Mile	4.33
Location	Crown
Category	Earthen Levee
Item	Crown Surface / Depressions / Rutting
Looking southeast at depression on waterside shoulder.	
richard_f_20121012_453.jpg

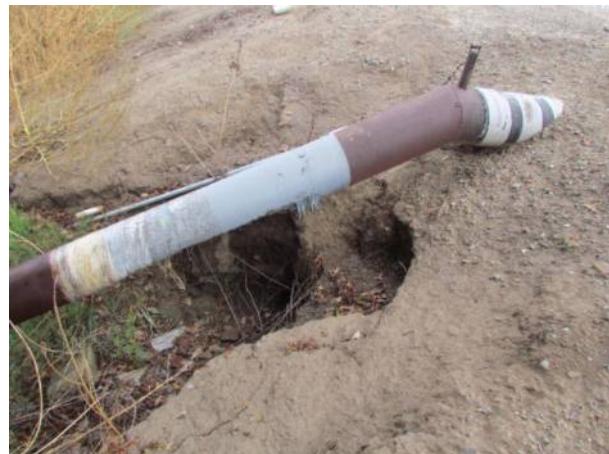
Levee Mile Report Line	55
Start Levee Mile	4.75
End Levee Mile	4.75
Location	Land Side
Category	Earthen Levee
Item	Slope Stability
Looking north at erosion around irrigation pipe on landside	
richard_f_20121012_444.jpg

DWR ID: DWR_RD0544_01_s_2012_27					
55	4.75	4.75	Earthen Levee	Slope Stability	LS Ma	S1 : Repair slope instability.			37.821626 ° -121.320471 °	37.821626 ° -121.320471 °				
									Y	DWR ID: DWR_RD0544_01_s_2012_28				
56	4.75	4.75	Earthen Levee	Animal Control	CR Ma	A3 : No rodents visible, but rodent burrows visible; need to backfill and compact or grout burrows.			37.821626 ° -121.320471 °	37.821626 ° -121.320471 °				
									DWR ID: DWR_RD0544_01_s_2012_29					
57	4.75	4.78	Earthen Levee	Vegetation	LS Ma	V2 : Remove the wild growth other than native grasses from the levee slopes.			37.821592 ° -121.320617 °	37.821253 ° -121.320927 °				
									DWR ID: DWR_RD0544_01_s_2012_26					
58	4.78	4.78	Earthen Levee	Encroachments	LS En	BU : Building Inspector Comments: New unauthorized pump shed on landside toe.			° °	° ° 45				
										DWR ID: DWR_RD0544_01_s_2012_45				
59	4.86	4.86	Earthen Levee	Encroachments	LS A/W Ma	PR : Prunings Inspector Comments: Remove dead stumps at landside toe and prunings on landside slope.			37.820227 ° -121.321115 °	37.820227 ° -121.321115 °

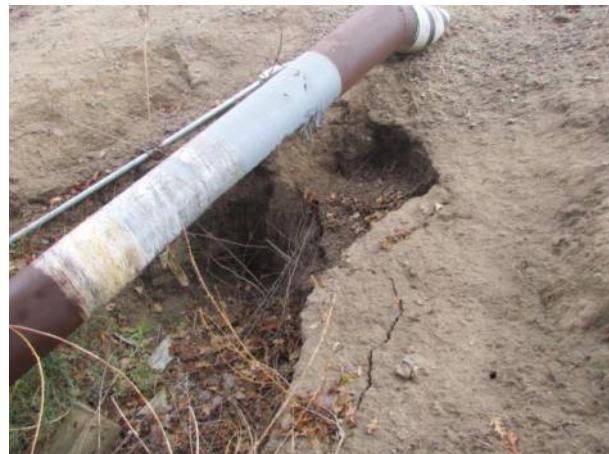
Levee Mile Report Line	55
Start Levee Mile	4.75
End Levee Mile	4.75
Location	Land Side
Category	Earthen Levee
Item	Slope Stability
Looking northeast at erosion around irrigation pipe on landside slope.	
richard_f_20121012_445.jpg

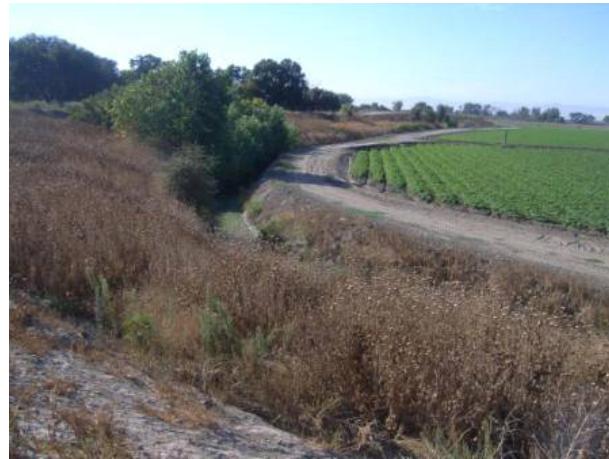
Levee Mile Report Line	62
Start Levee Mile	4.96
End Levee Mile	4.96
Location	Land Side
Category	Earthen Levee
Item	Encroachments
Looking southwest at ditch on landside slope and toe.	
richard_f_20121012_457.jpg

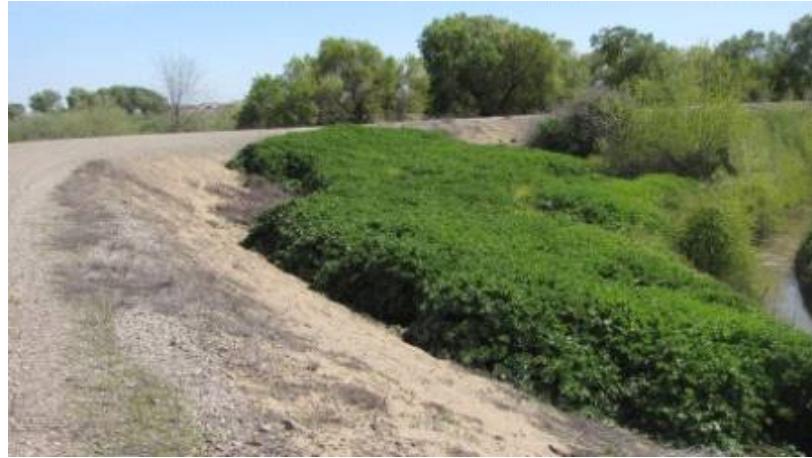
Levee Mile Report Line	63
Start Levee Mile	5.00
End Levee Mile	5.30
Location	Land Side
Category	Earthen Levee
Item	Vegetation
Looking southeast at dense veg. on landside slope and toe.	
richard_f_20121012_446.jpg

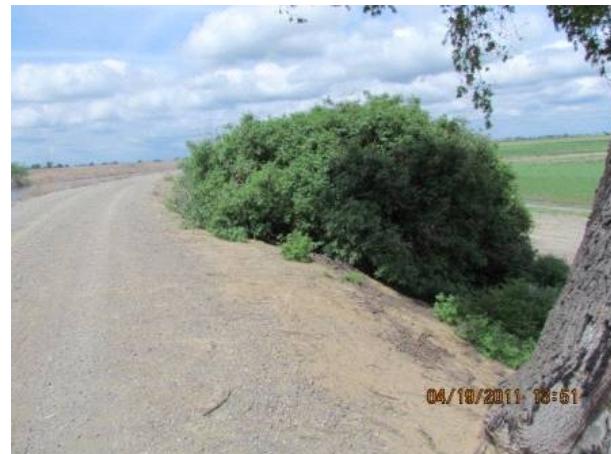
Levee Mile Report Line	2
Start Levee Mile	0.41
End Levee Mile	0.41
Location	Land Side
Category	Earthen Levee
Item	Vegetation
Looking south at elderberries on landside slope.	
richard_f_20121012_459.jpg

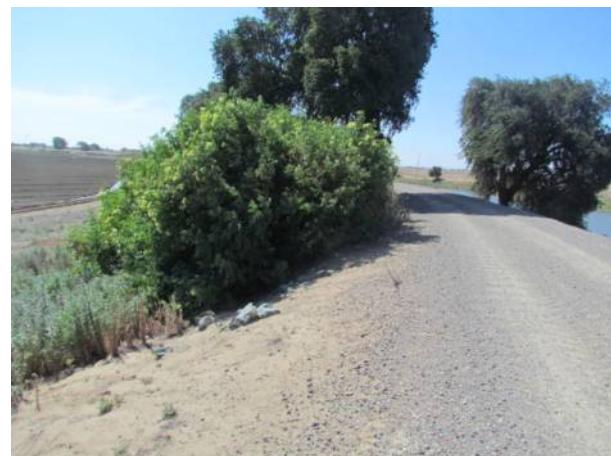
Levee Mile Report Line	2
Start Levee Mile	0.41
End Levee Mile	0.41
Location	Land Side
Category	Earthen Levee
Item	Vegetation
Looking northwest at elderberry on landside slope. (Spring 2012)	
richard_f_20121012_460.jpg

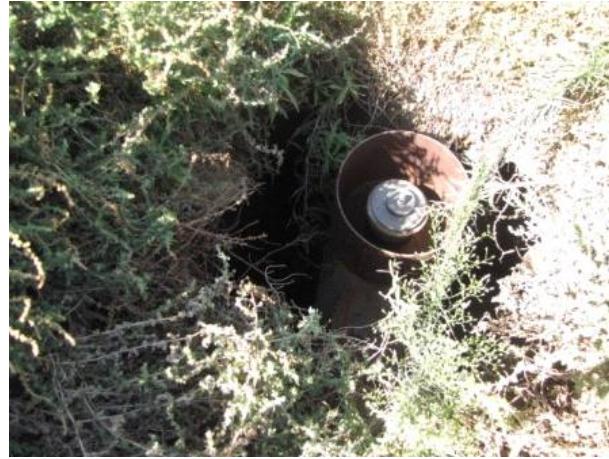
Levee Mile Report Line	7
Start Levee Mile	0.79
End Levee Mile	0.79
Location	Water Side
Category	Interior Drainage & Piping Systems
Item	Erosion Areas
Looking at top of siphon on waterside shoulder with 3' of caving around pipe.	
richard_f_20121012_463.jpg

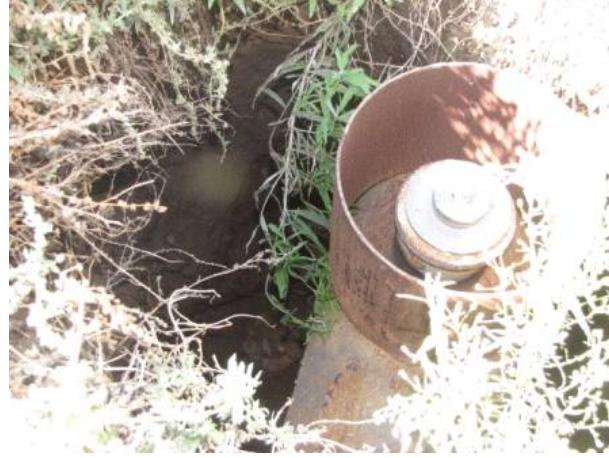
Levee Mile Report Line	7
Start Levee Mile	0.79
End Levee Mile	0.79
Location	Water Side
Category	Interior Drainage & Piping Systems
Item	Erosion Areas
Looking at caving around 10" siphon pipe on waterside shoulder.	
richard_f_20121012_464.jpg

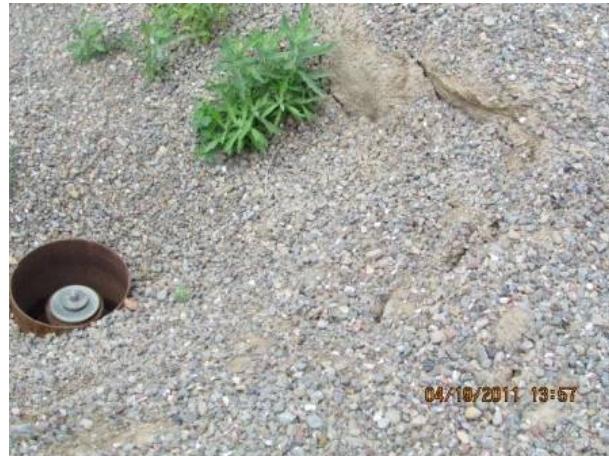
Levee Mile Report Line	7
Start Levee Mile	0.79
End Levee Mile	0.79
Location	Water Side
Category	Interior Drainage & Piping Systems
Item	Erosion Areas
Looking at top of siphon with a depression greater than 6" on waterside shoulder.	
richard_f_20121012_467.jpg

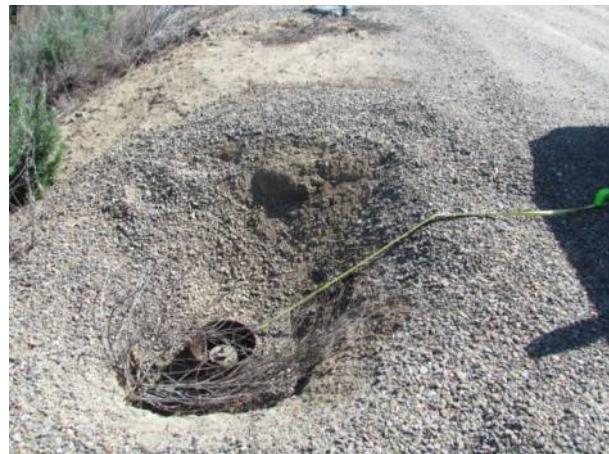
Levee Mile Report Line	7
Start Levee Mile	0.79
End Levee Mile	0.79
Location	Water Side
Category	Interior Drainage & Piping Systems
Item	Erosion Areas
Looking south at caving around siphon on waterside shoulder.(Spring 2012)	
richard_f_20121012_469.jpg

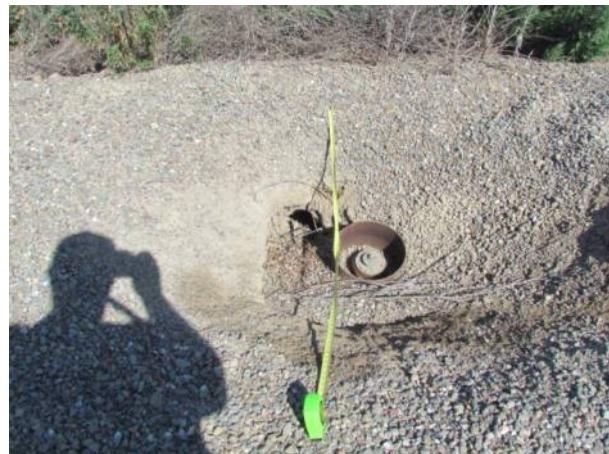
Levee Mile Report Line	7
Start Levee Mile	0.79
End Levee Mile	0.79
Location	Water Side
Category	Interior Drainage & Piping Systems
Item	Erosion Areas
Looking east at caving around siphon on waterside shoulder. (Spring 2012)	
richard_f_20121012_470.jpg

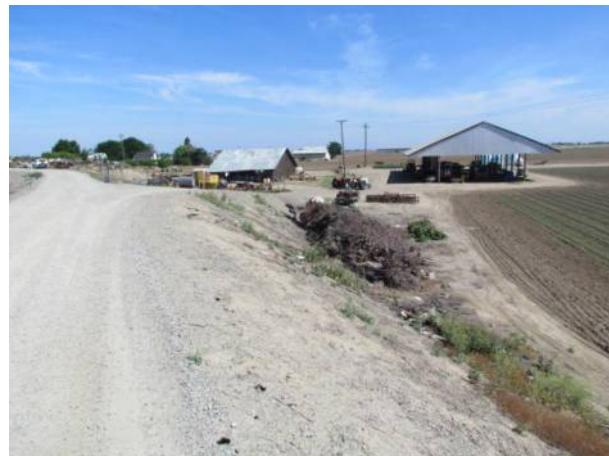
Levee Mile Report Line	9
Start Levee Mile	1.14
End Levee Mile	1.14
Location	Land Side
Category	Earthen Levee
Item	Encroachments
Looking southwest at garbage and pruning pile at landside toe.(Spring 2012)	
richard_f_20121012_486.jpg

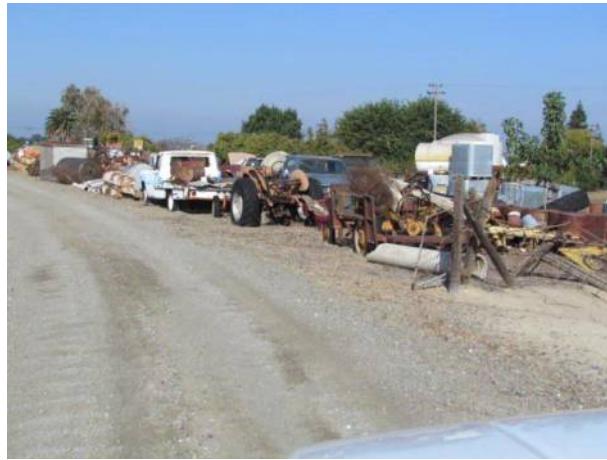
Levee Mile Report Line	11
Start Levee Mile	1.17
End Levee Mile	1.23
Location	Land Side
Category	Earthen Levee
Item	Encroachments
Looking southwest at farm equipment, vehicles, and other items stored on landside landing.	
richard_f_20121115_497.jpg

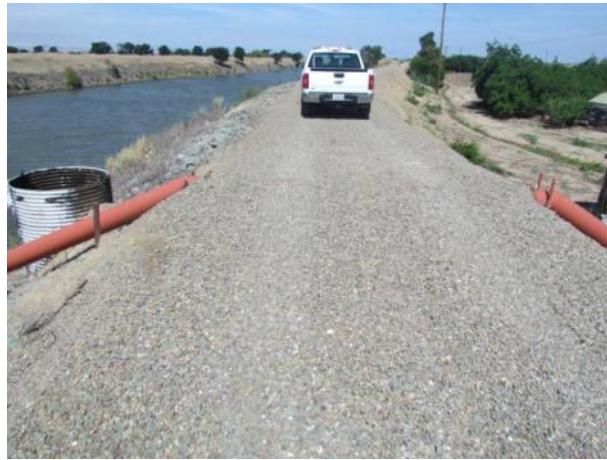
Levee Mile Report Line	13
Start Levee Mile	1.26
End Levee Mile	1.26
Location	Crown
Category	Earthen Levee
Item	Encroachments
Looking south at covering and ramp over irrigation pipe.	
richard_f_20121012_484.jpg

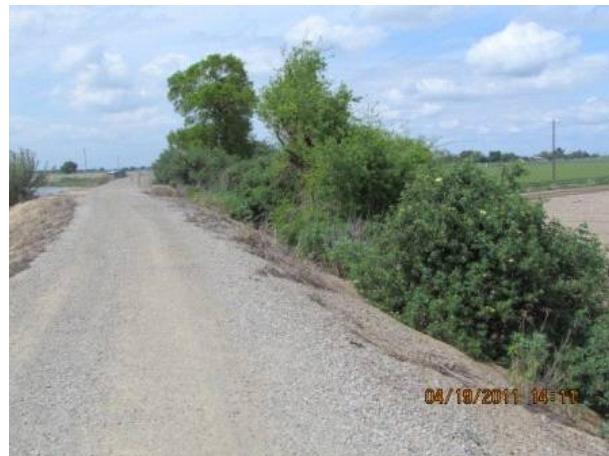
17	1.41	1.41	Earthen Levee	Vegetation	LS Ma	U	V4 : Elderberries are blocking visibility and flood fight capability.	37.821423 °	37.821423 °	10	-121.337878 ° -121.337878 ° Y
											DWR ID: DWR_RD0544_02_s_2012_10
18	1.44	1.44	Earthen Levee	Slope Stability	LS Ma	M	S2 : Repair the levee slope damaged by foot traffic and prevent access where possible.	37.821697 °	37.821697 °	22	-121.338397 ° -121.338397 ° Y
											DWR ID: DWR_RD0544_02_s_2012_22
19	1.47	1.47	Earthen Levee	Animal Control	WS Ma	M	A1 : Exterminate rodents and backfill and compact or grout burrows.	37.821954 °	37.821954 °	28	-121.338715 ° -121.338715 °
											DWR ID: DWR_RD0544_02_s_2012_28
20	1.48	1.48	Earthen Levee	Encroachments	LS En	U	TR : Tree or limb Inspector Comments: Dead tree and limbs should be remove from landside shoulder and slope	37.822082 °	37.822082 °	23	-121.338932 ° -121.338932 ° Y
											DWR ID: DWR_RD0544_02_s_2012_23

Levee Mile Report Line	17
Start Levee Mile	1.41
End Levee Mile	1.41
Location	Land Side
Category	Earthen Levee
Item	Vegetation
Looking southwest at elderberries on landside slope.	
richard_f_20121012_472.jpg

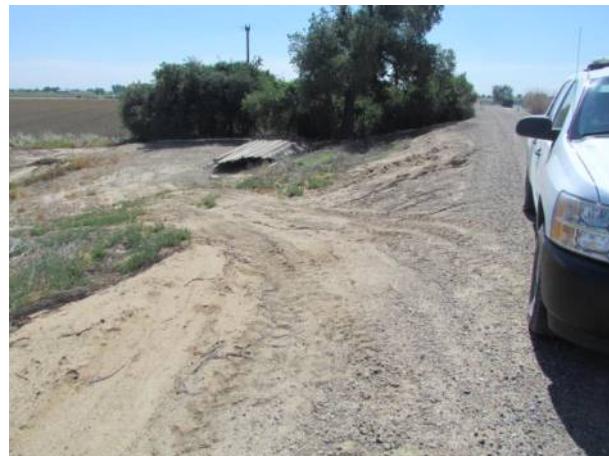
Levee Mile Report Line	18
Start Levee Mile	1.44
End Levee Mile	1.44
Location	Land Side
Category	Earthen Levee
Item	Slope Stability
Looking northwest at slope damage caused by vehicle traffic.	
richard_f_20121012_490.jpg

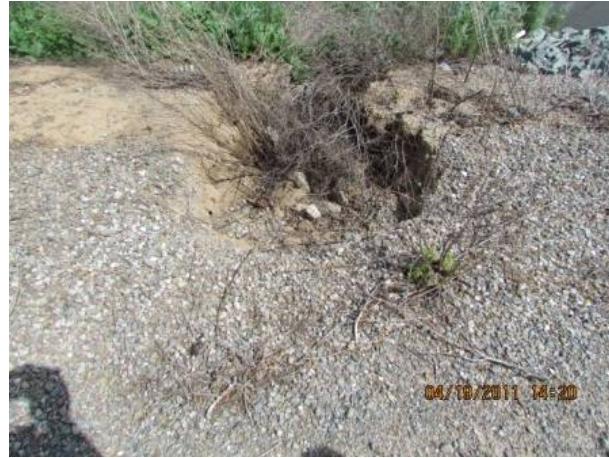
Levee Mile Report Line	22
Start Levee Mile	1.89
End Levee Mile	1.89
Location	Water Side
Category	Earthen Levee
Item	Slope Stability
Looking east at depression and slope stability on waterside slope.	
richard_f_20121012_476.jpg

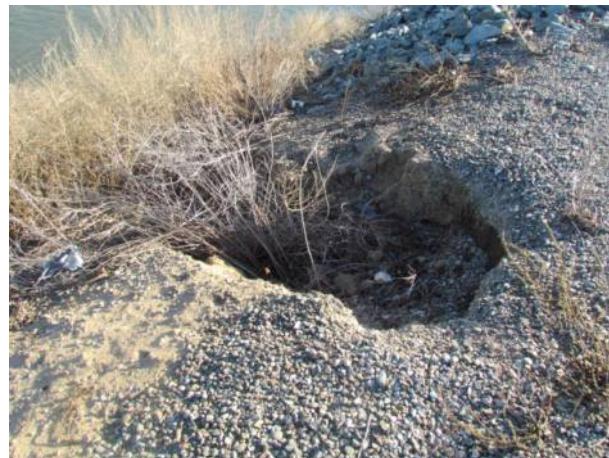
Levee Mile Report Line	22
Start Levee Mile	1.89
End Levee Mile	1.89
Location	Water Side
Category	Earthen Levee
Item	Slope Stability
Looking southeast at caving on waterside shoulder. (Fall Inspection)	
richard_f_20121012_478.jpg

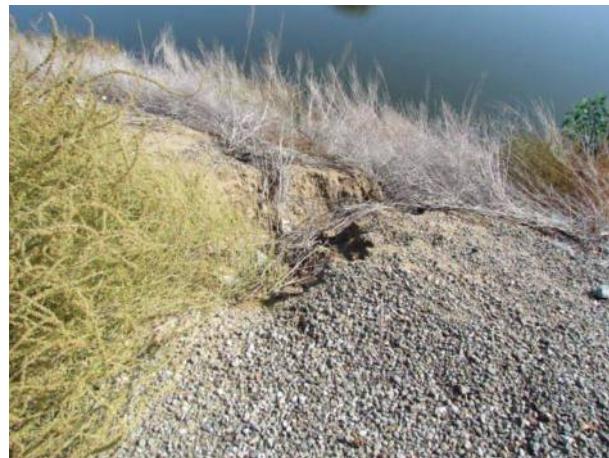
Levee Mile Report Line	22
Start Levee Mile	1.89
End Levee Mile	1.89
Location	Water Side
Category	Earthen Levee
Item	Slope Stability
Looking east at vertical erosion on waterside slope.	
richard_f_20121115_498.jpg

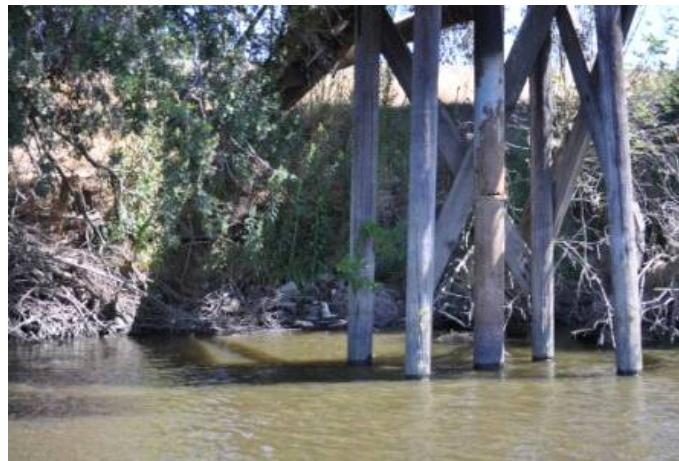
Levee Mile Report Line	29
Start Levee Mile	2.34
End Levee Mile	2.34
Location	Water Side
Category	Supplemental
Item	DWR Erosion Survey
Front view of the erosion site. View is partially blocked by the pump structure and vegetation	
SJR2012_RD0544U02RM33.21_1.jpg

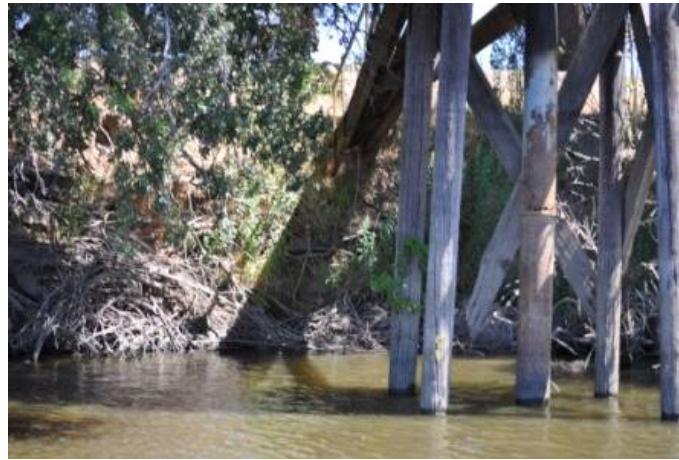
Levee Mile Report Line	29
Start Levee Mile	2.34
End Levee Mile	2.34
Location	Water Side
Category	Supplemental
Item	DWR Erosion Survey
Front view of the site	
SJR2012_RD0544U02RM33.21_2.jpg

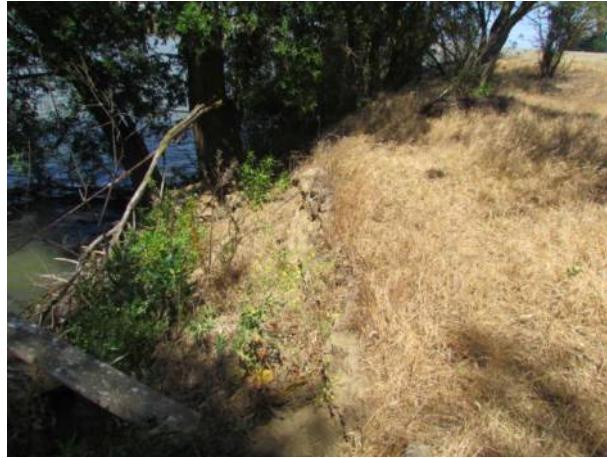
Levee Mile Report Line	30
Start Levee Mile	2.35
End Levee Mile	2.35
Location	Water Side
Category	Channels
Item	Erosion / Bank Caving
Looking south at river erosion at waterside toe near pumping station.	
richard_f_20121012_494.jpg

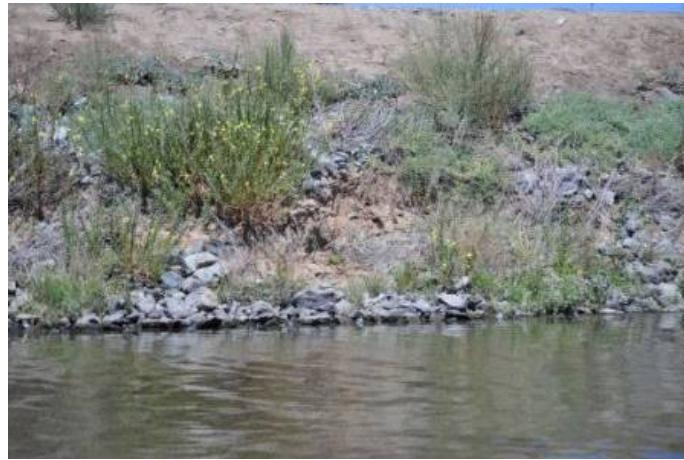
Levee Mile Report Line	35
Start Levee Mile	2.65
End Levee Mile	2.67
Location	Water Side
Category	Supplemental
Item	DWR Erosion Survey
Front view of pocket erosion. Note the vegetation and riprap rocks at the site	
<i>SJR2012_RD0544U02RM32.91_1.jpg</i>
